Performance of stainless steel in marine applications

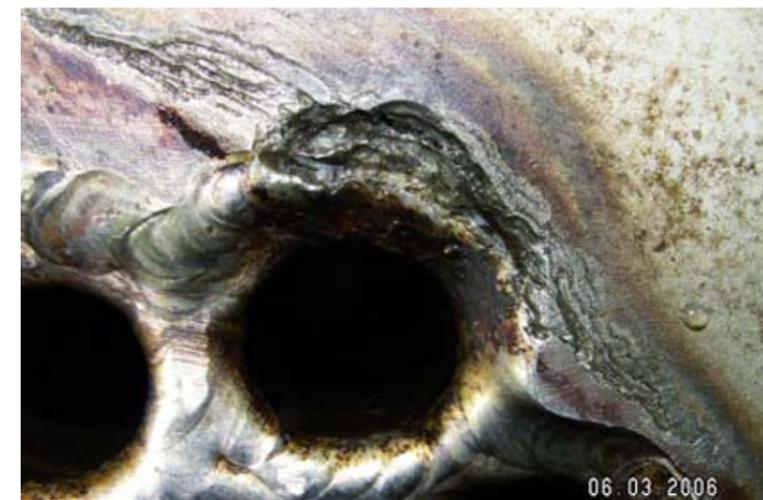
Picture 1: Crevice corrosion in seawater cooler. This corrosion finally leads to leakages.

In marine environment stainless steel will never corrode uniformly. Corrosion is localised, i.e.: pitting corrosion and crevice corrosion. Localised corrosion often is being promoted by a biofilm. Picture 1 shows an example of crevice corrosion in a tubular heat exchanger. Crevice corrosion is a major problem in marine environment because of the low resistivity of the water (seawater resistivity is about 0,35 Ohm.m). Even 6% Mo SS at 30 °C can suffer crevice corrosion in seawater. If chlorinated, seawater below 25 °C will not cause pitting corrosion to duplex stainless steel 2205

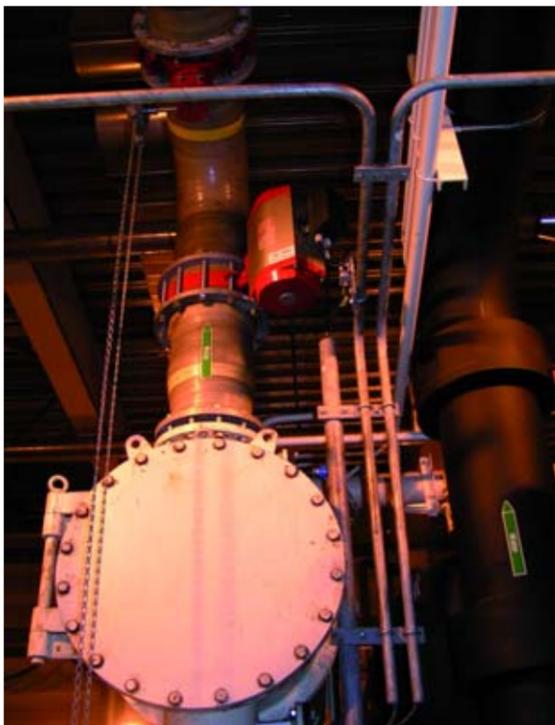
Picture 2: Position of cast-iron valve compared to duplex SS seawater cooler.

5. A cast iron butterfly valve showed extreme rapid corrosion. Failure analysis by Corrodium proved that this was caused by galvanic corrosion. The valve was positioned in a GRE (glass fibre reinforced epoxy) pipe on close distance to a huge duplex stainless steel sea water cooler. The valve was operated by an electrical engine and both the valve and the cooler were grounded. The galvanic current through the ground link was measured at 340 mA! For safety and economical reasons, the ground connection could not be changed and there-

fore the solution in this case was either choice for a stainless steel valve, or installing a sacrificial anode in the GRE pipe (and connecting the anode to the valve. See picture 2 and 3.

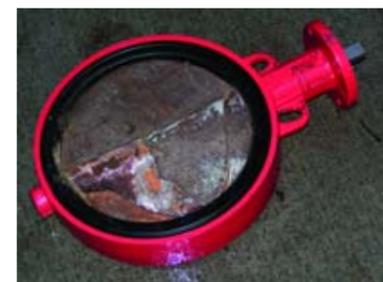
Picture 3: Severe galvanic corrosion of cast iron butterfly valve due to ground-contact with noble seawater cooler.

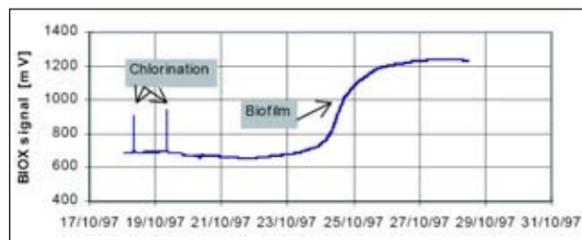
Picture 4: The current demand of a biofilm causes corrosion of stainless steel, but, in the same time also can be used to monitor on biofilm formation. Both the biofilm as the chlorination itself cause a current increase. The mV signal was measured as Voltage drop over a resistance between a stainless steel surface and a sacrificial anode.

can be illustrated with the BIOX bio film monitor. A stainless steel surface is connected to a zinc anode. A resistor (e.g. 1 Ohm) has been switched between the stainless steel and the anode. The Voltage drop over the resistor indicates the anode current. $100\text{ mV} = 100\text{ mA}$ according to Ohms law. If the biofilm is forming, the potential drop and the anode current will increase, thus proving the current demand of the biofilm. After a badge shot of hypochlorite, the biofilm has destroyed. The potential and current return to original values.

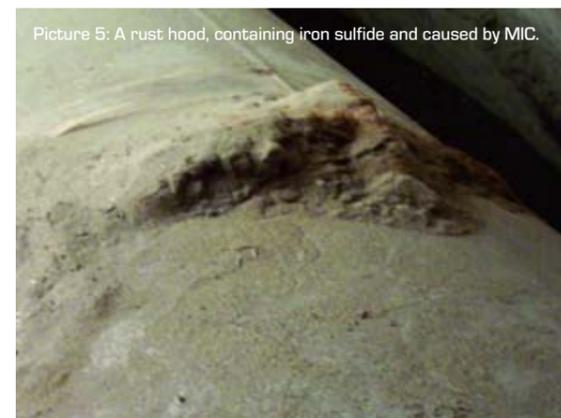
Picture 5: A rust hood, containing iron sulfide and caused by MIC.

Another failure analysis that was conducted concerns buried stainless steel 316L pipelines in a wastewater recovery plant. The internal of the pipelines contained dry air at 80 °C. The external of the pipeline was surrounded by brackish ground water (resistivity 113 Ohm.cm). Ideal circumstances were created for extreme corrosion. The bacteria very much like the warm pipe wall and started acid production to penetrate the pipe wall within 6 months on many places. The appearance of SRB corrosion in stainless steel is very typically. A rust hood, containing metal-sulfides, is formed and below this hood the pH-value can decrease to <3 . Iron-containing acid will drip out of the rusthood and a brown ring of rust deposits is formed around the rust hood.

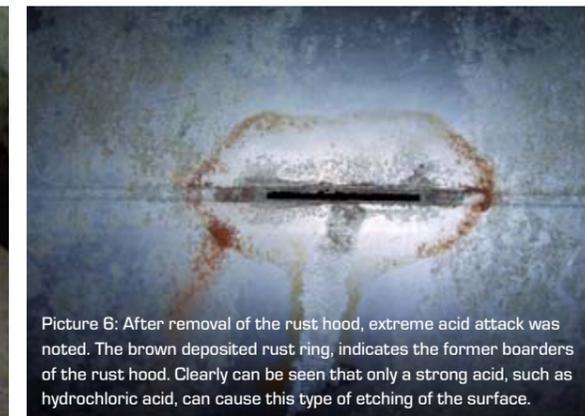
Picture 6: After removal of the rust hood, extreme acid attack was noted. The brown deposited rust ring, indicates the former borders of the rust hood. Clearly can be seen that only a strong acid, such as hydrochloric acid, can cause this type of etching of the surface.
